Technical Report M13

**BANK EROSION STUDY OF THE KASKASKIA RIVER,  
CARLYLE LAKE  
TO NEW ATHENS, ILLINOIS**

Prepared For  
U.S. Army Corps of Engineers  
St. Louis District

February 2000

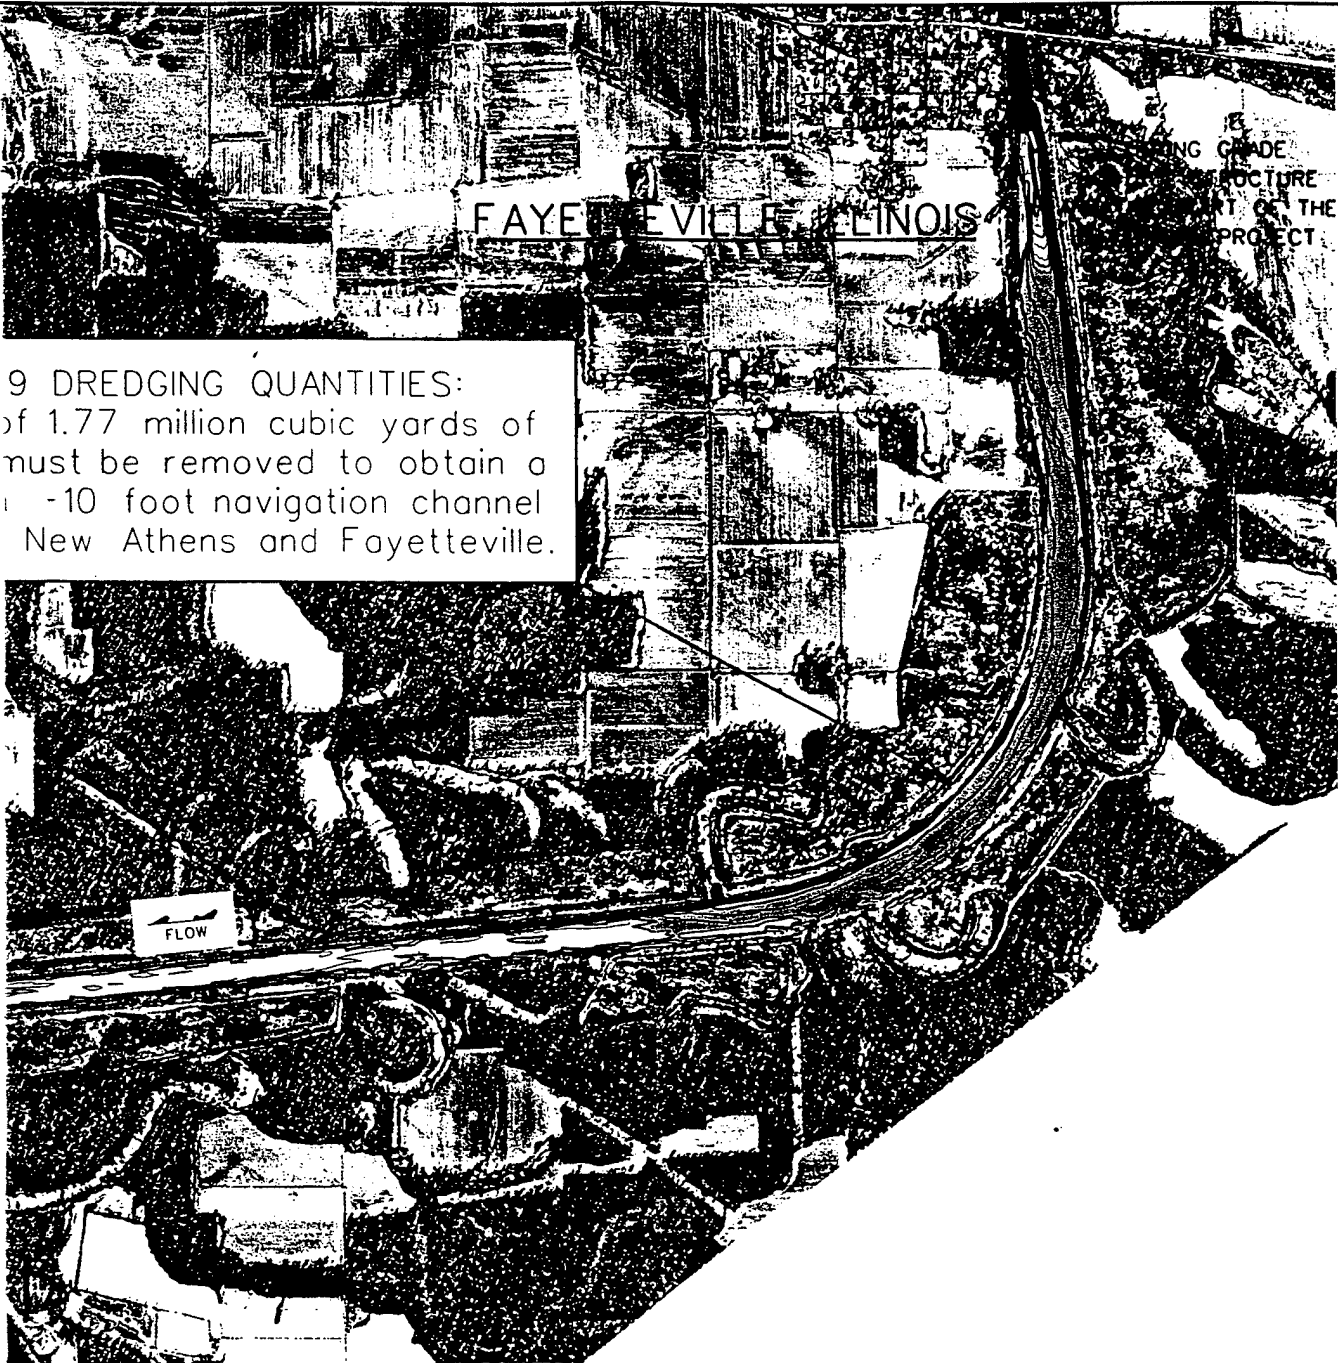
No dredging has occurred in the navigation channel since 1985. Hydrographic surveys of the channel conducted in 1999 indicated that approximately 1.77 million cubic yards of sediment had again accumulated in the 6-mile stretch of the navigation project, between Fayetteville and New Athens (Plate 3).

1999 DREDGING QUANTITIES:  
A total of 1.77 million cubic yards of material must be removed to obtain a minimum -10 foot navigation channel between New Athens and Fayetteville.

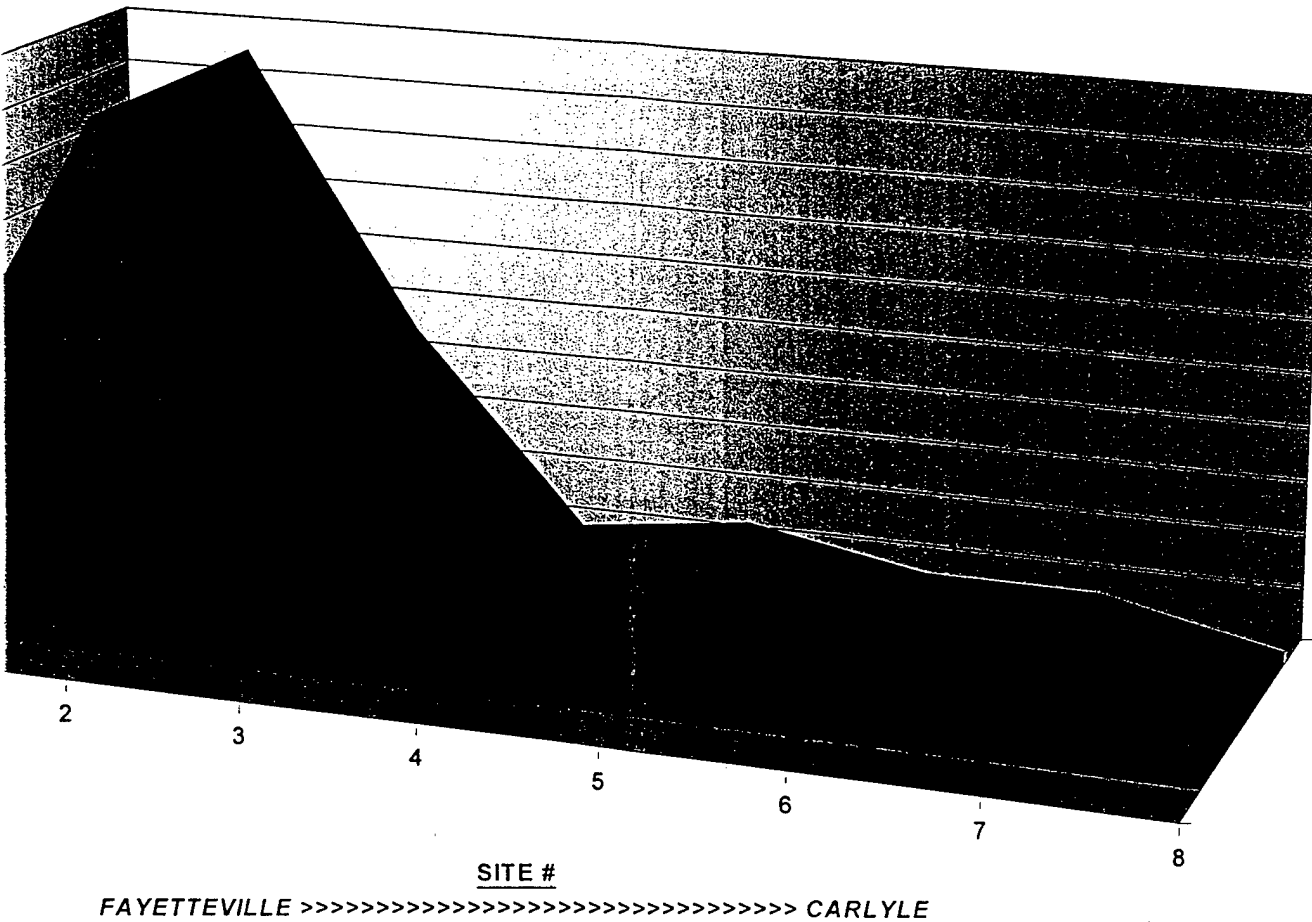
## CHANNEL WIDENING RATES FROM 1962 TO 1998

The **dimension** of the study reach was determined using historical aerial photography. A comparison was made with 1962 photography, which pre-dates construction of the multi-purpose lake projects and the navigation project. Conditions in 1962 were assumed as the "base dimensions", although it must be kept in mind that bank erosion is a natural river process and has always occurred on the Kaskaskia River to some degree. Eight strategic locations along the river reach were selected, and channel widening measurements and rates were computed using 1978, 1988 and 1998 photography. A comparison of the data is presented in Plate 5.

It should be noted that in 1962 the channel contained a constant width of approximately 125 feet throughout the entire length of the project reach. The

channel dimensions showed no tendency to widen below the major associated tributaries of Shoal Creek, Crooked Creek and Elkhorn Creek. Subsequent measurements taken from the 1978 through 1998 photographs showed that the channel had widened significantly over time in the lower portion of the study. The greatest changes occurred from Fayetteville to the area near "Highbanks" at bend # 124 (site 3 on Plate 5). Channel widening rates were approximately 5 feet per year in some bends within this reach. Width changes were progressively smaller as the analysis moved upstream, with the rates calculated as small as 0.1 feet per year just downstream of Carlyle Lake (site #8 on Plate 5).

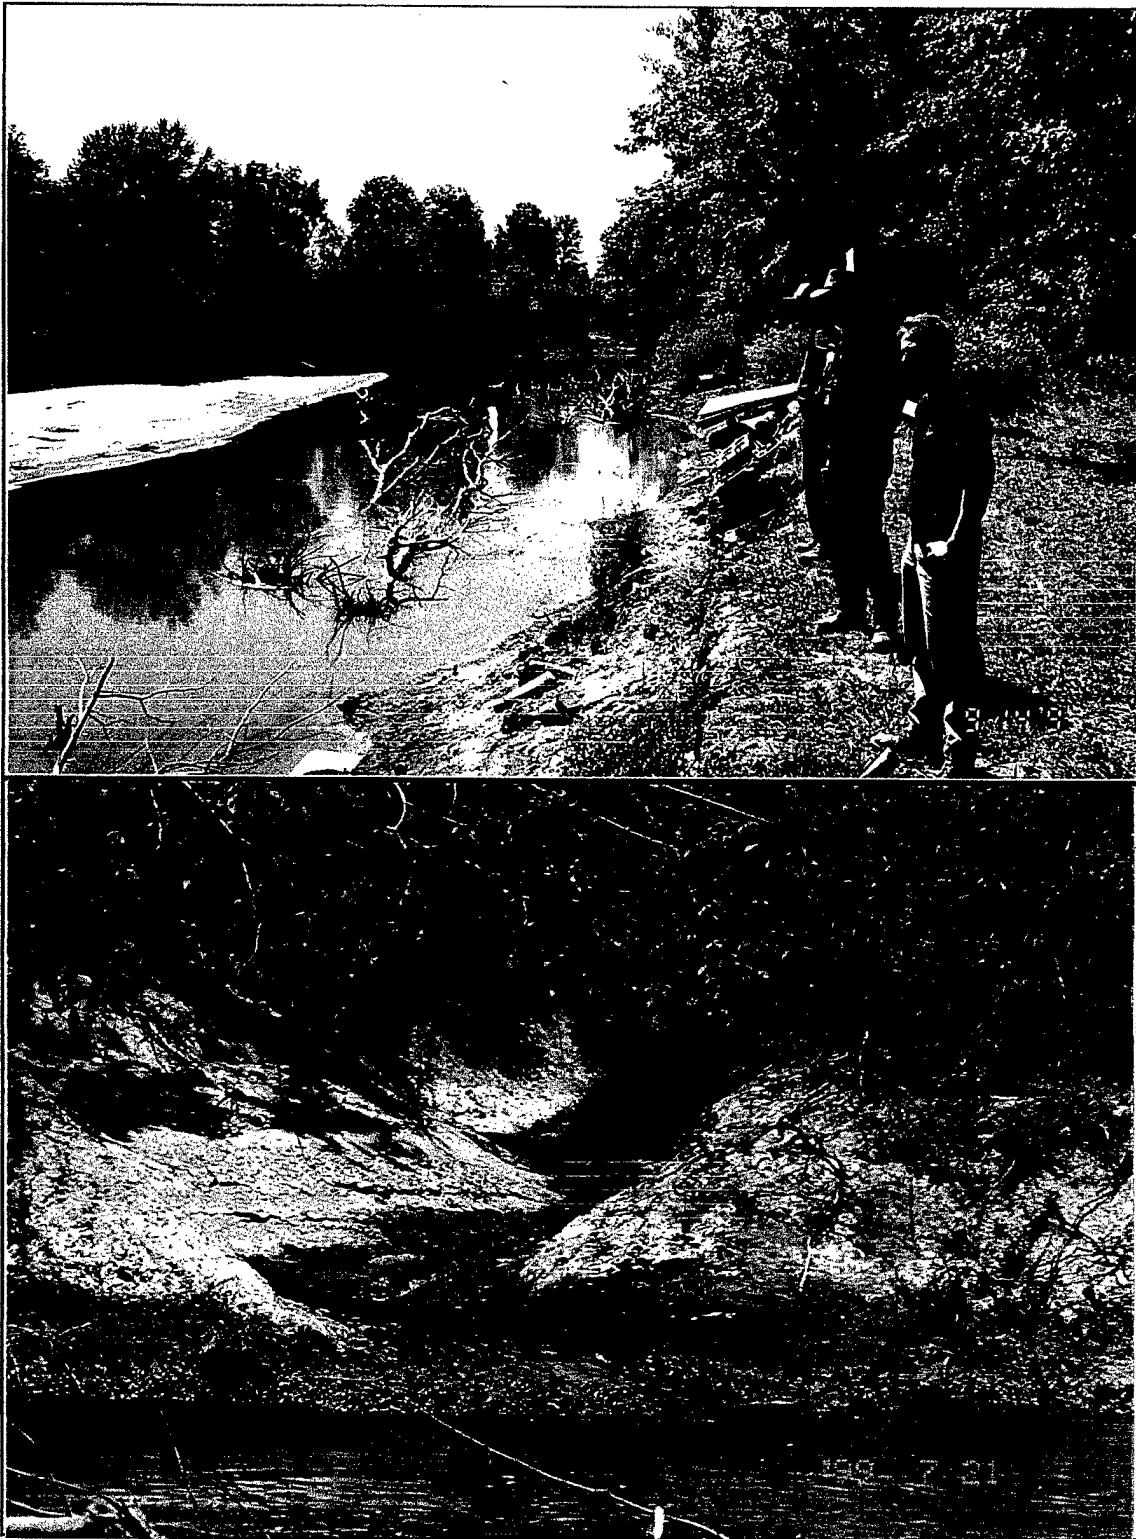
7

Top Photo: Excessive vegetative debris lining the river channel indicates increased bankline erosion.

Bottom Photo: Perched tributary indicates a lowering or scouring of the channel profile.

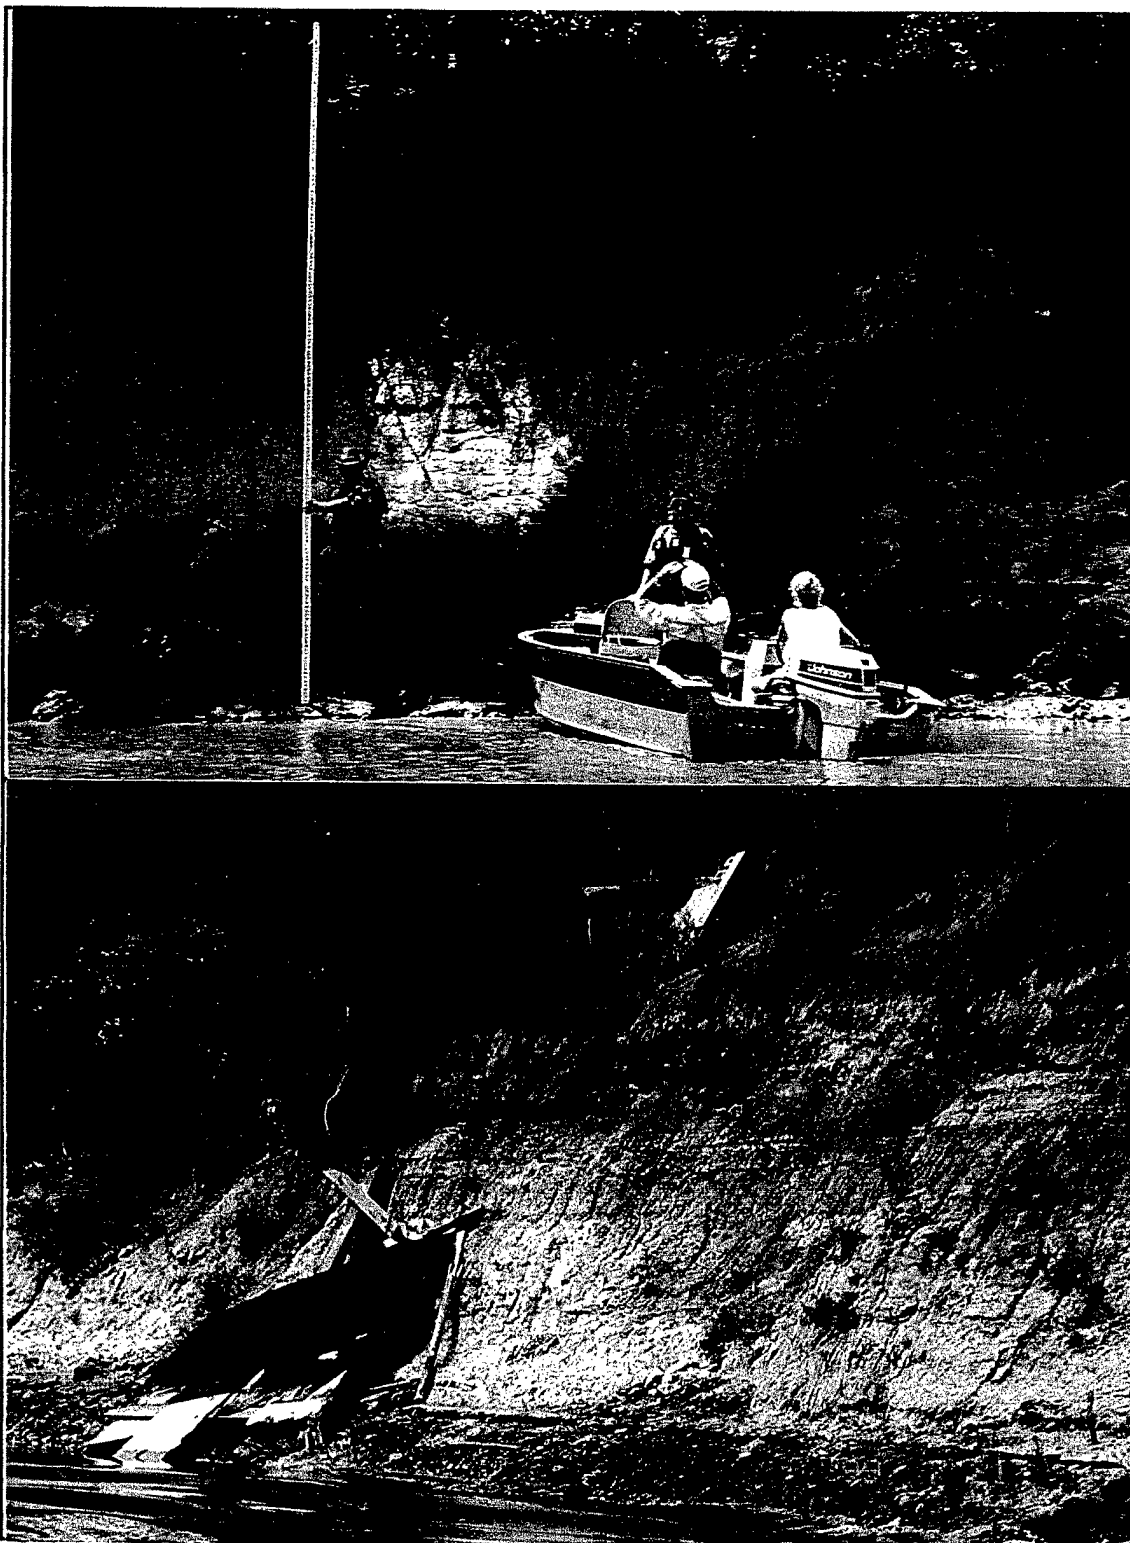
8

**Top Photo:** Banklines have eroded excessively to become unnaturally high and steep with little vegetation.

**Bottom Photo:** Excessive bankline erosion has caused increased property loss
